Reference **Hexa-Cover® Floating Cover**
Application **Wastewater**
Effect **Controlling odor, algae and evaporation**
Location **Napa County, CA, USA**

Napa Berryessa Resort Improvement, Napa, CA, USA chose Hexa---Cover® Floating Cover for a wastewater application for controlling odor, algae and evaporation. Hexa---Cover® Floating Cover is installed at Lake Berryessa Wastewater Treatment plant, 1465 Steele Canyon Road, Napa. The application is to cover two concrete equalization basins.

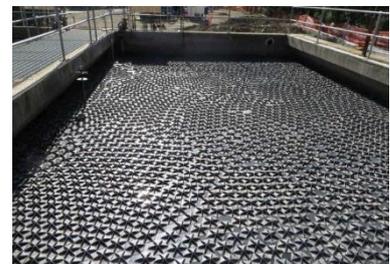
“The visit to the plant was a bit amazing. There was no odor from the “Hexa---Covered” EQ Basins. These EQ basins have very high odor potential and algae potential because of the heavy nutrients coming off the screen. There was no algae, the discs as advertised interlocked, they floated up and down with no problem, and could not help but reduce evaporation.

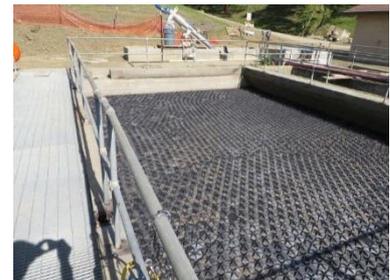
A solid cover presented safety issues, the Hexa---Cover® discs did not. Summit Engineers was going to put aeration in these basins but saw a sample of the Hexa---Cover® product, called references then recommended the Hexa---Cover® installation. It penciled out better than aeration. That was important to this design build project, which Western Water Constructors, Inc. did with Summit.

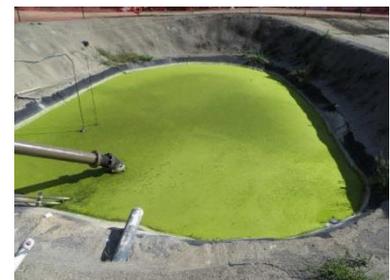
Adjacent to these equalization basins are the effluent basin and overflow basin. These two basins were covered with algae. The point, the Hexa---Cover® Floating Cover eliminates Algae!

As proof, side by side basins, same plant, same time, two “Hexa---Covered” basins without algae and two uncovered basins with heavy algae. Also, no odor from the EQ basins.
